**Flood Control Project Maintenance  
Levee Inspections**  
**LMA District Cover Sheet**  
**Spring 2018 Levee Inspection Results**

**Sacramento Maintenance Yard Putah Creek**

**Spring 2018 Levee Inspection Results**

Waterway			Bank	Unit Miles
Unit No. 01 Putah Creek or North Levee			Left	8.79
	Spring (March - May)	Summer (June - August)	(September - November) Fall	Winter (December - February)
Unit Maintenance Rating (Fall Only)				
Date of Inspection	3/8/2018 - 3/8/2018			
DWR Inspector	Keith Millard			
Accompanied By

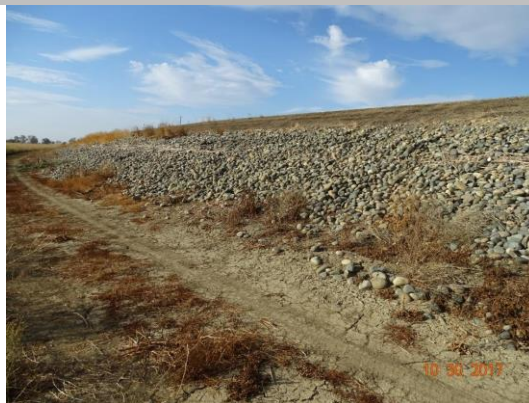
Photo 1 of 1 : SP\_2018\_ST0007\_282\_2\_20180305\_00001.jpg

10/30/17: Cobbles and waterside toe appear intact; similar to conditions extending to 0.46.

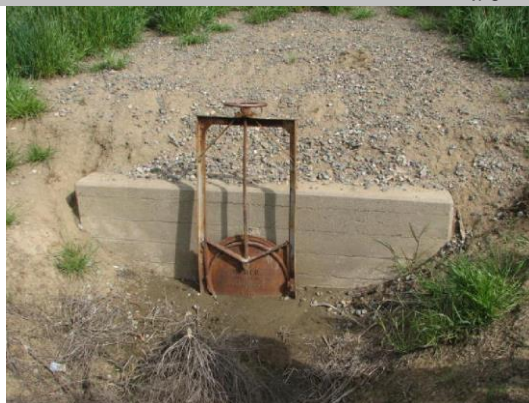
Photo 1 of 3 : UCIP\_SP\_2018\_33408\_60493.jpg

WS slide gate and headwall

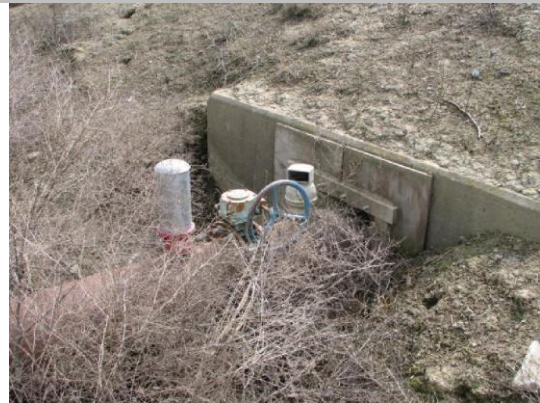
Photo 3 of 3 : UCIP\_SP\_2018\_48122\_60482.jpg

Comment Code						
Inspector Comment						
FS_ID:48122 DS_ID:489 EP_NO: 10262 Repair Type: Non-Urgent Crossing Status: Found UCIP Comments: Pump is disconnected from pipe and could cause backflow at highwater event. Can't see size of pipe sleeved through 24-inch pipe. FIELD_STRUCT_DESC: 18-inch steel irrigation pipe (field verified not 16-inch) sleeved through existing 24-inch drainage steel pipe through levee, 12.5 feet below the crown. Annular space sealed at both the waterside (WS) and landside (LS) ends. Concrete headwalls are located on both the WS and LS ends. PVC sleeved December of 2007 (unknown source). (16-inch pipe sleeved through 24-inch pipe authorized under Automatic Board Order (ABO) issued as Permit No. 10262, 1974 - Wells Fargo Bank, Trustee for S.H. Cowell Foundation) [Additional Reference(s): DWR Levee Log, March 2007. USACE Sacramento O&M Manual 119, December 1952] FS Date: 4/10/2014 2:48:00 PM

Butterfly valve at LS toe

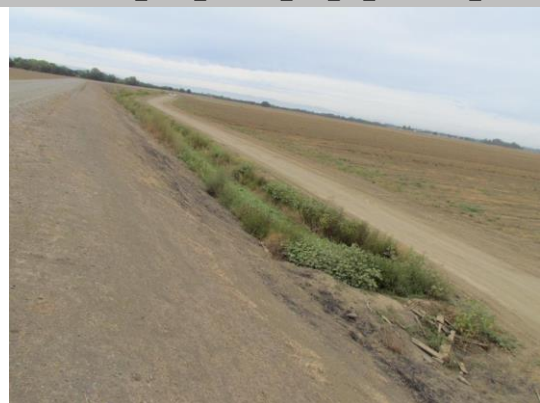
Photo 1 of 1 : SP\_2018\_ST0007\_282\_10\_20180305\_00005.jpg

LM Start	1.52	Rating **	M	Issue No.	10
LM End	2.67	Issue Type +	En	Location *	LS
Category	Earthen Levee			GPS Latitude/Longitude	
				Start	End
Item	Encroachments			38.515258 °	38.517376 °
				-121.655107 °	-121.676054 °
DWR ID	DWR_ST0007_01_s_2012_10				
Comment Code					
DT : Ditch					
Inspector Comment					
This agriculture ditch is owned by Dos Rios Farms. Ending at levee mile 2.72 landside.

Agriculture ditch within 10-foot of levee toe.

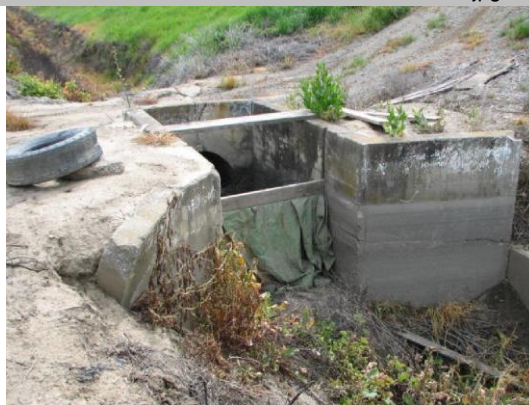
Photo 2 of 3 : UCIP\_SP\_2018\_43033\_60467.jpg

LS distribution box

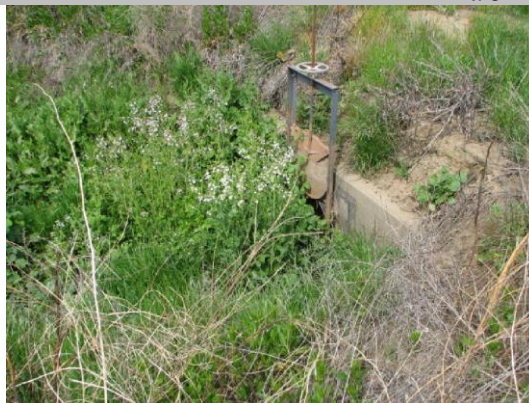
Photo 3 of 3 : UCIP\_SP\_2018\_43033\_60466.jpg

WS slide gate with vegetation

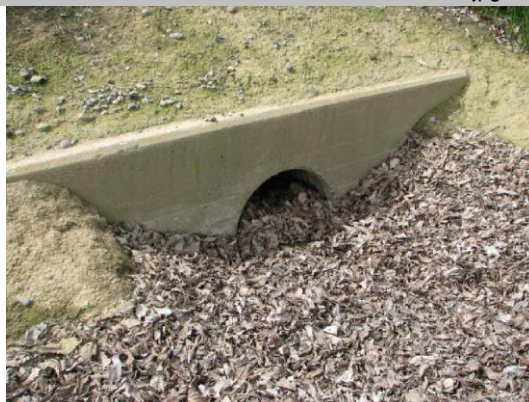
Photo 2 of 2 : UCIP\_SP\_2018\_33394\_60457.jpg

LS headwall

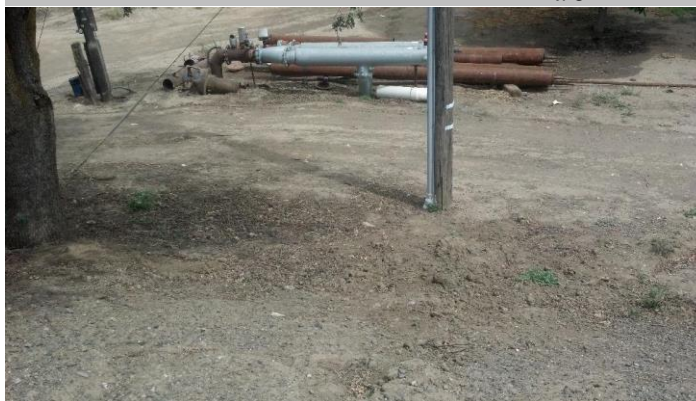
Photo 1 of 3 : UCIP\_SP\_2018\_48013\_60451.jpg

Filter Plant on LS toe

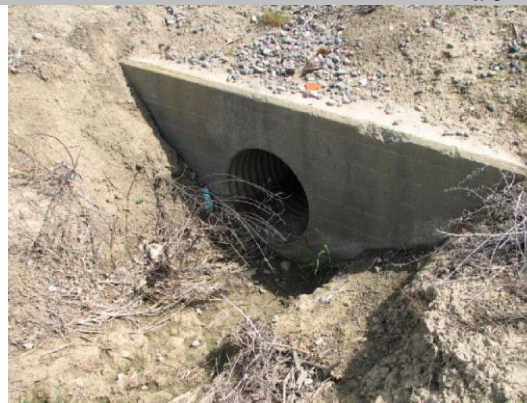
Photo 2 of 3 : UCIP\_SP\_2018\_33381\_60441.jpg

LS headwall and pipe

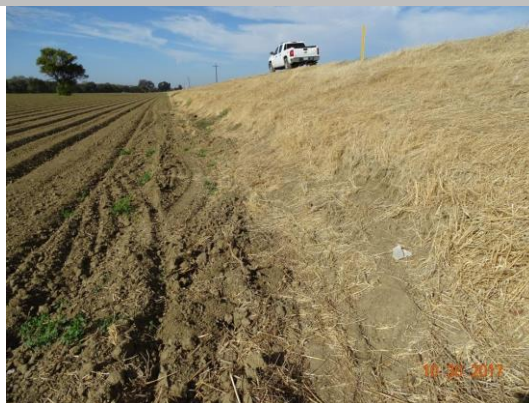
Photo 1 of 1 : SP\_2018\_ST0007\_282\_37\_20180305\_00006.jpg

Agricultural tilling has encroached into waterside levee toe. Activity should cease and toe should be repaired.

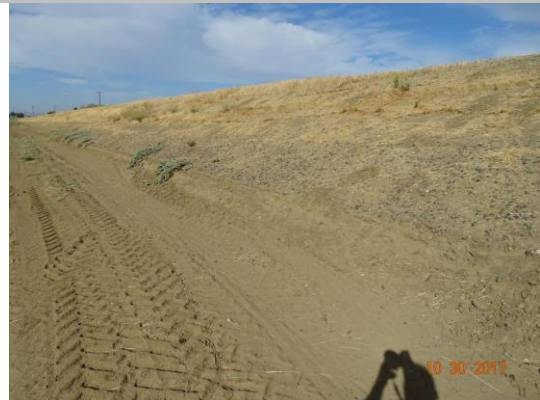
Photo 1 of 1 : SP\_2018\_ST0007\_282\_50\_20180305\_00007.jpg

Agricultural tilling has encroached into waterside levee toe. Activity should cease and toe should be repaired.

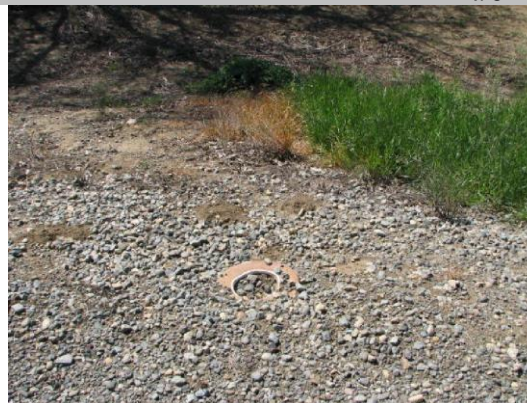
Photo 3 of 3 : UCIP\_SP\_2018\_33367\_60407.jpg

WS shoulder broken air vent

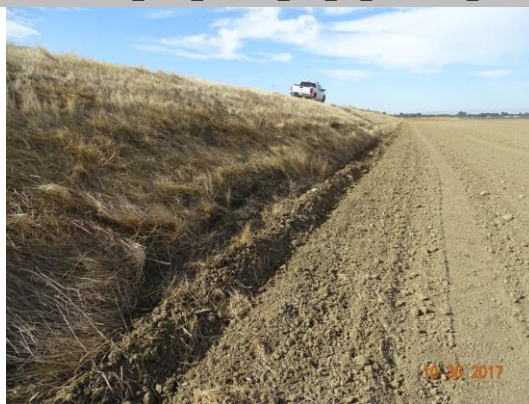
Photo 1 of 2 : SP\_2018\_ST0007\_282\_53\_20180305\_00008.jpg

Agricultural tilling has encroached into landside levee toe. Activity should cease and toe should be repaired.

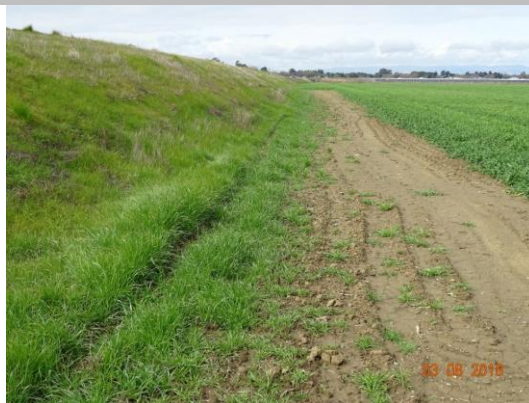
Photo 2 of 2 : SP\_2018\_ST0007\_282\_53\_20180312\_00108.jpg

Fleld not currently planted in area were tilling previously encroached on levee toe. Continue to monitor. Toe should be repaired.

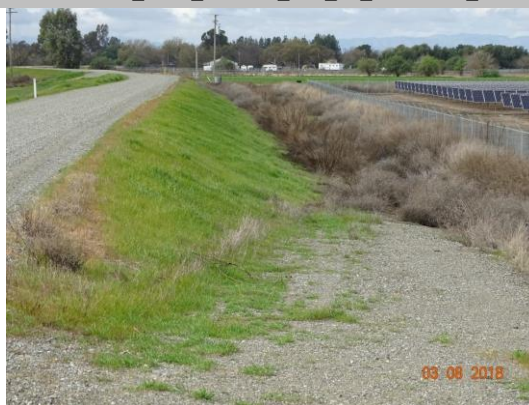
Photo 1 of 1 : SP\_2018\_ST0007\_282\_36\_20180312\_00109.jpg

Large weeds at levee toe are dead, but should be removed to allow inspection and access.

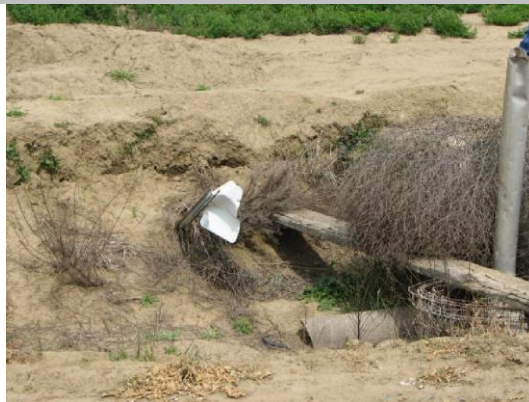
Photo 2 of 2 : UCIP\_SP\_2018\_33347\_60365.jpg

LS: sign post bent over in v ditch at toe.

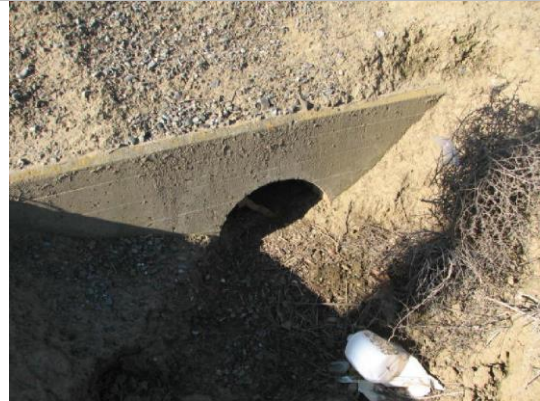
Photo 2 of 2 : UCIP\_SP\_2018\_41353\_60344.jpg

LS headwall showing pipe partially blocked with soil.

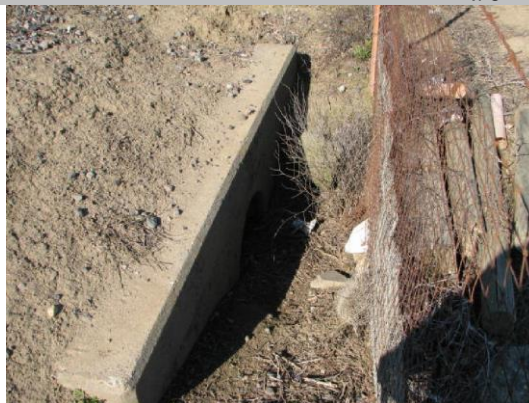
Photo 2 of 2 : UCIP\_SP\_2018\_33333\_60341.jpg

LS headwall showing fence and soil buildup.

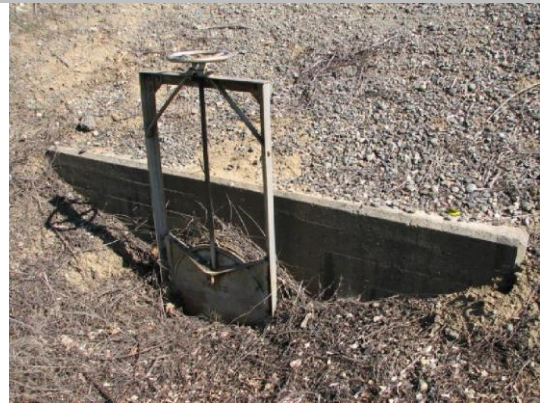
Photo 3 of 3 : UCIP\_SP\_2018\_33328\_60328.jpg

WS slide gate showing some blockage with soil.

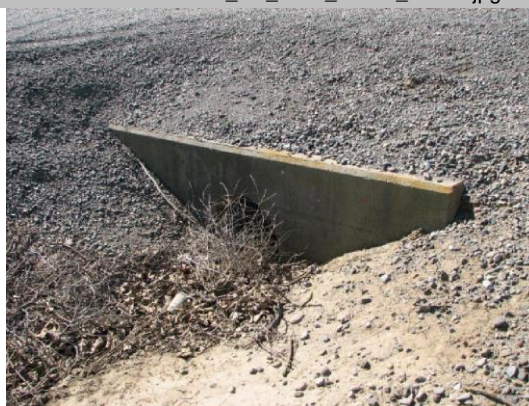
Photo 2 of 2 : UCIP\_SP\_2018\_33327\_60325.jpg

LS headwall showing partial blockage

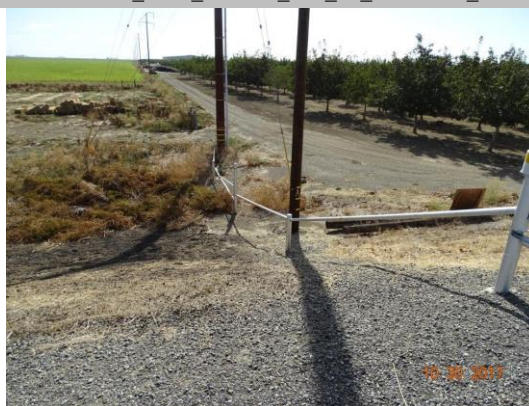
Photo 4 of 4 : SP\_2018\_ST0007\_283\_29\_20180305\_00009.jpg

No CVFPB Permit for this gate. DWR - Sac Maintenance Yard installed this gate a few years ago.

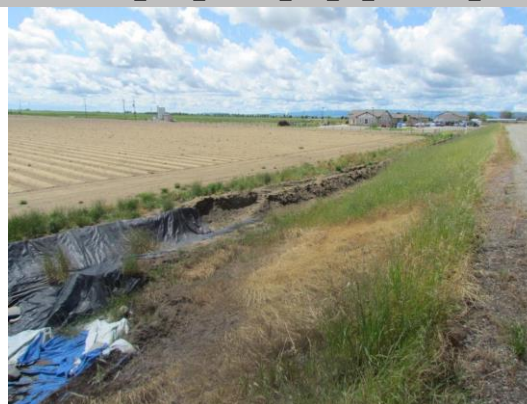
Photo 1 of 1 : SP\_2018\_ST0007\_283\_34\_20180305\_00010.jpg

Landside levee toe levee mile 4.97-5.00 looking upstream unauthorized agriculture ditch placed within the easement. No permit for this encroachment.

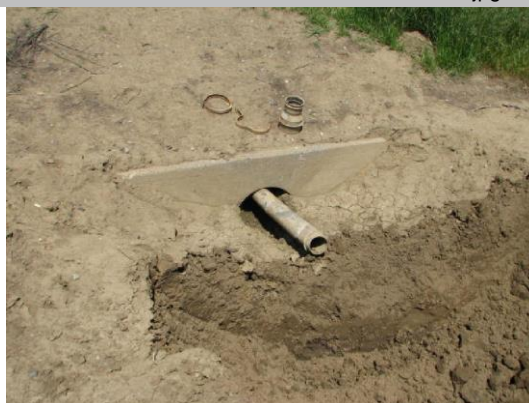
Photo 2 of 2 : UCIP\_SP\_2018\_33363\_60398.jpg

LS headwall showing sedimentation and 6-inch pipe sleeved through 24-inch pipe.

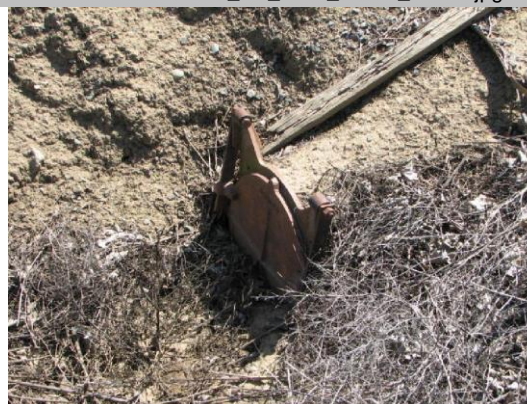
Photo 1 of 2 : UCIP\_SP\_2018\_42953\_60397.jpg

WS Flapgate blocked by sedimentation

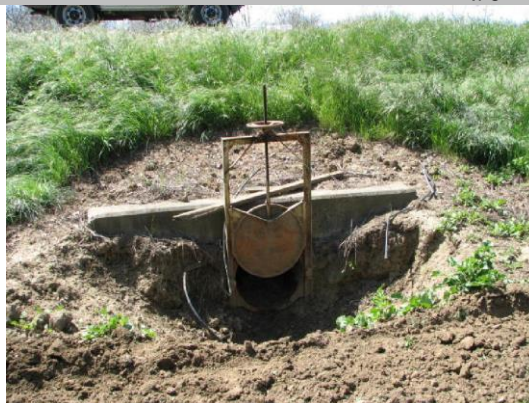
Photo 1 of 2 : UCIP\_SP\_2018\_33346\_60364.jpg

WS slide gate showing soil plug

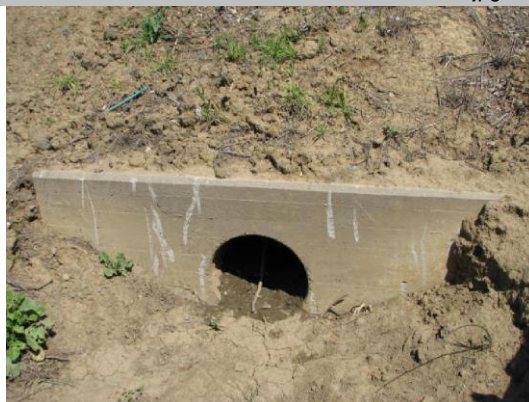
Photo 2 of 2 : UCIP\_SP\_2018\_33346\_60363.jpg

LS headwall showing soil plug

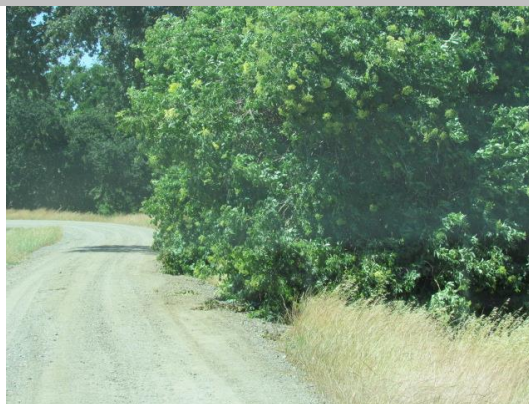
Photo 1 of 1 : SP\_2018\_ST0007\_283\_47\_20180305\_00013.jpg

Elderberry bushes blocking view of waterside shoulder at this location.
